# Regaining the Client's Trust

Using science-based data instead of just verbal assurances, a contractor is able to test validity of concrete repairs without resorting to large-scale demolition

By Andy Schrader, M.S.C.E., E.I.

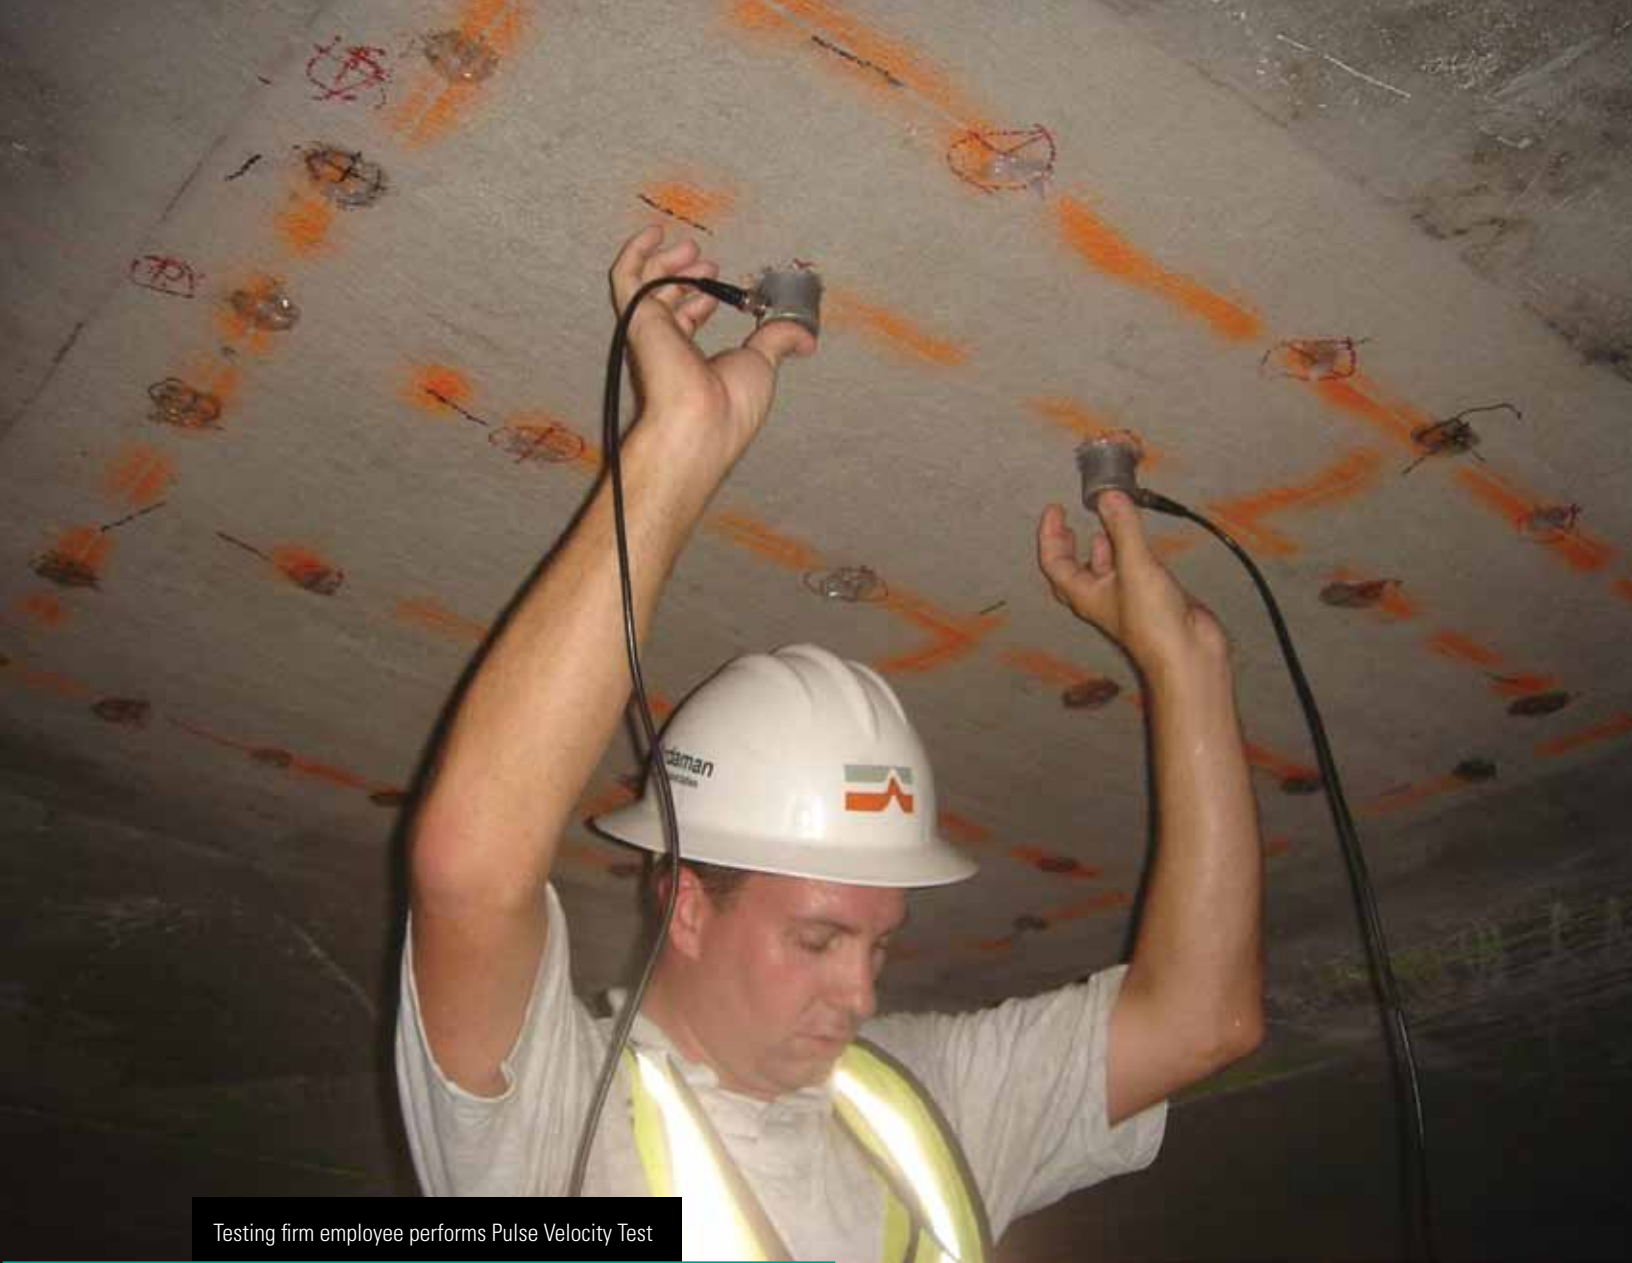
Testing firm employee performs Pulse Velocity Test

A proposal from a local testing company using pulse velocity testing (PVT) was finally approved. Pulse velocity testing is defined in ASTM International C597-02. It uses an electro-acoustical transducer to generate stress waves in the concrete. The speed that these waves travel can indicate the presence of voids or cracks. Unusually long transit times may indicate that the waves have traveled a farther distance to bypass cracks or voids.

The testing firm was given a drawing showing the concrete repair areas and asked to test many of the areas. A 12-inch testing grid was drawn on the concrete repairs and the slab was tested at each one of those points. Areas where longer transit times were measured were marked as "suspect" locations. It is prudent to verify non-destructive data with selective physical explorations. In this case many of the suspect locations were further examined through discrete destructive exploration.

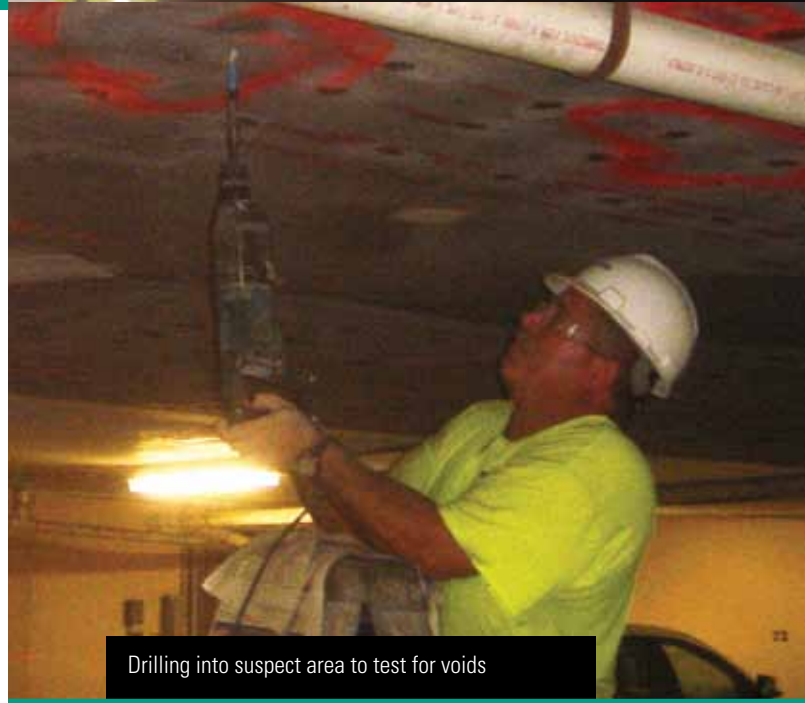
Drilling into suspect area to test for voids

About 1,800 discrete points were tested using the Pulse Velocity Method. Of these, about 600 were marked as suspect using criteria from American Concrete Institute's (ACI) Manual of Concrete Inspection. Sixty-seven of those suspect areas were examined using 3/8" diameter hand held drills. One additional void of structurally insignificant size was found. All other tested areas appeared to consist of dense, well-bonded repair material.

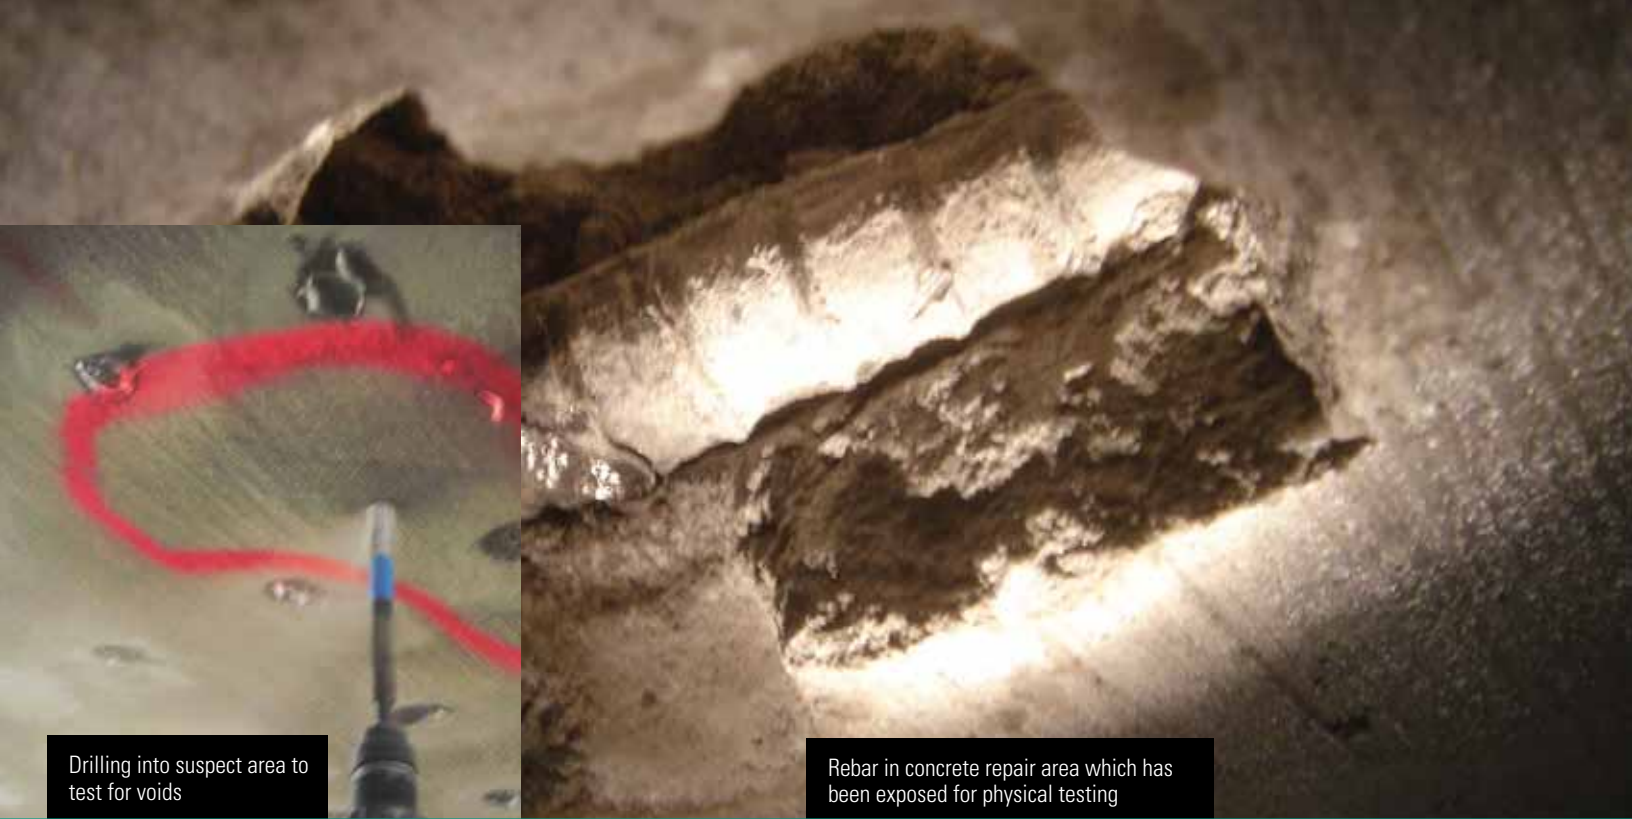
Drilling into suspect area to test for voids

Rebar in concrete repair area which has been exposed for physical testing

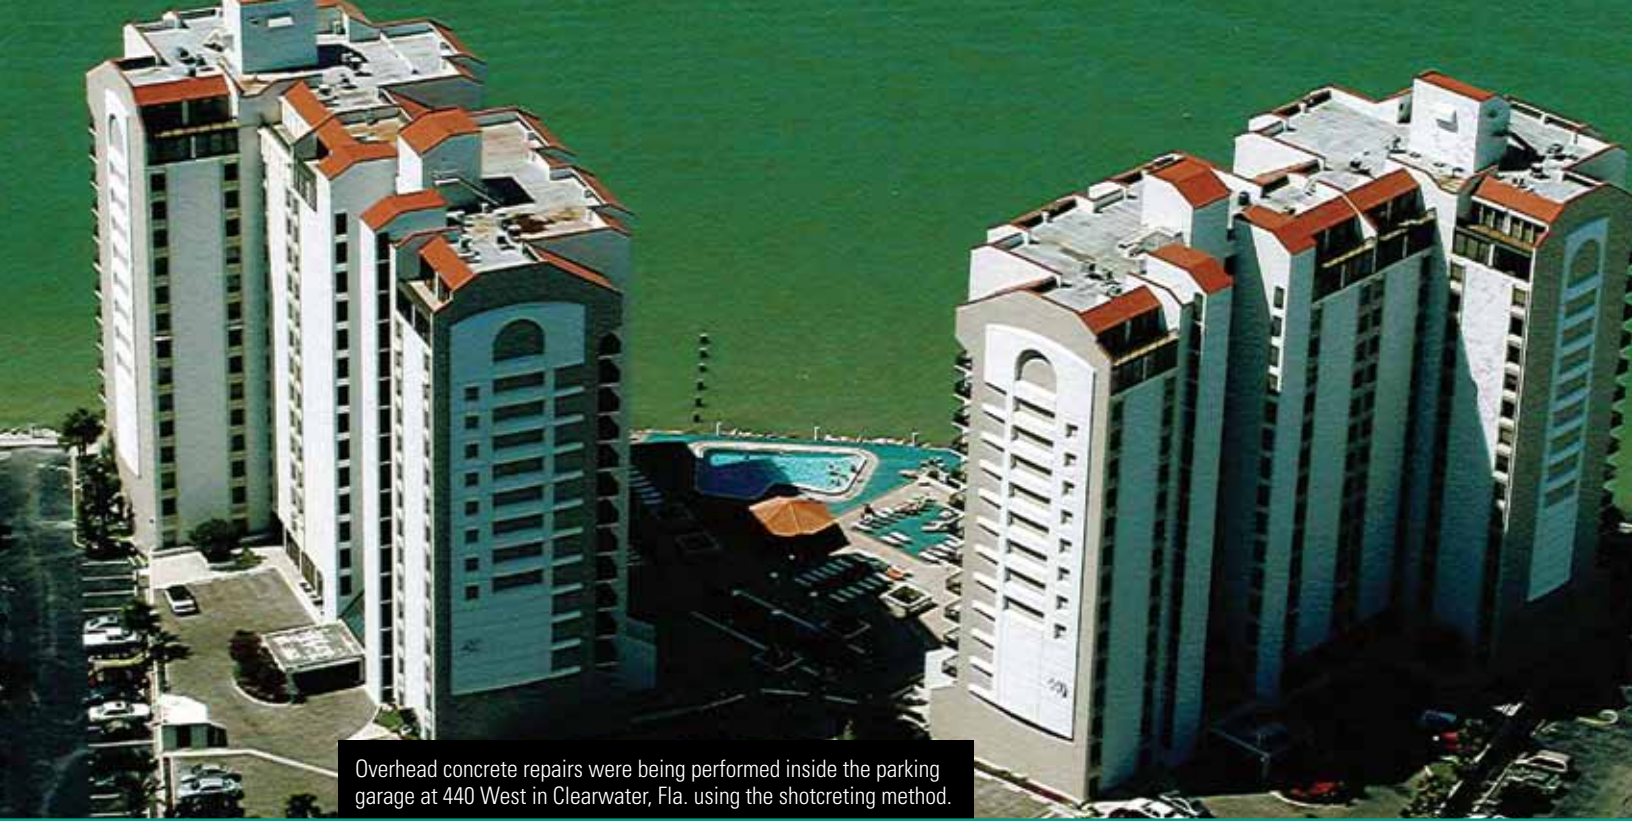
Overhead concrete repairs were being performed inside the parking garage at 440 West in Clearwater, Fla. using the shotcreting method.

Overhead concrete repairs were being performed inside the parking garage using the shotcreting method. Quality control tests for the shotcrete material included taking concrete cores of the repair area to test the bond strength between the repair material and the virgin concrete.
